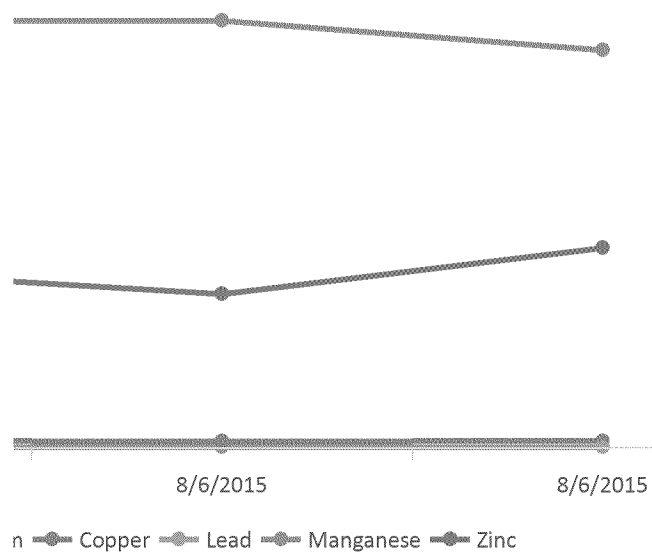
Location: 32nd Street Bridge

ocation ID	Date Sampled	Cadmium	Copper	Lead	Manganese	Zinc
32nd St Br	8/5/2015	0.178	1.7	0.24	105	43.5
32nd St Br	8/6/2015	0.16	1.56		105	37.8
32nd St Br	8/6/2015	0.19	1.62	0.115	97.8	49.1

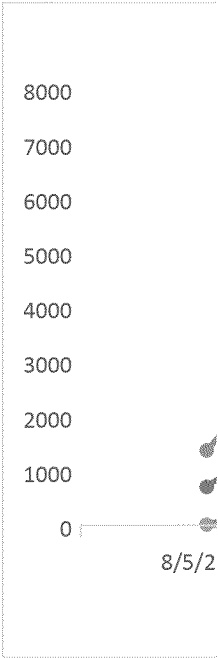
Location: A72

Location ID	De Sampled	Cadmium	Copper	Lead	Manganese	Zinc
A72	8/5/2015	1.81	9.27	0.225	1370	699
A72	8/5/2015	15.2	1410	50.7	6650	4020
A72	8/5/2015	4.29	205	3.12	1810	1210
A72	8/5/2015	2.59	11.4	0.118	1320	733
A72	8/6/2015	2.11	7.63		1160	609

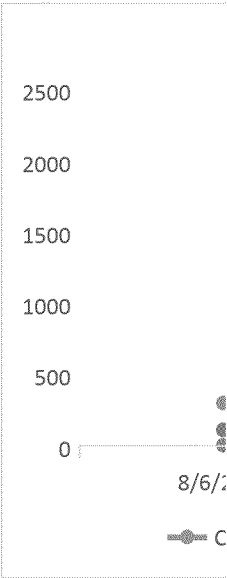
Location: Bakers Bridge

ocation ID	De Sampled	Cadmium	Copper	Lead	Manganes	Zinc
Bakers Bri	8/6/2015	0.336	1.88		296	110
Bakers Bri	8/6/2015	5.32	189	1.56	2090	1700
Bakers Bri	8/5/2015	0.353	2.28		306	85.8
